Residual-Strength Analysis of Primary Aircraft Structure Damaged Due to Projectile Impact and Penetration

Volume I Test and Analysis

GEORGIA INSTITUTE OF TECHNOLOGY
ATLANTA, GEORGIA 30332

FINAL REPORT FOR PERIOD NOVEMBER 1975 -FEBRUARY 1977

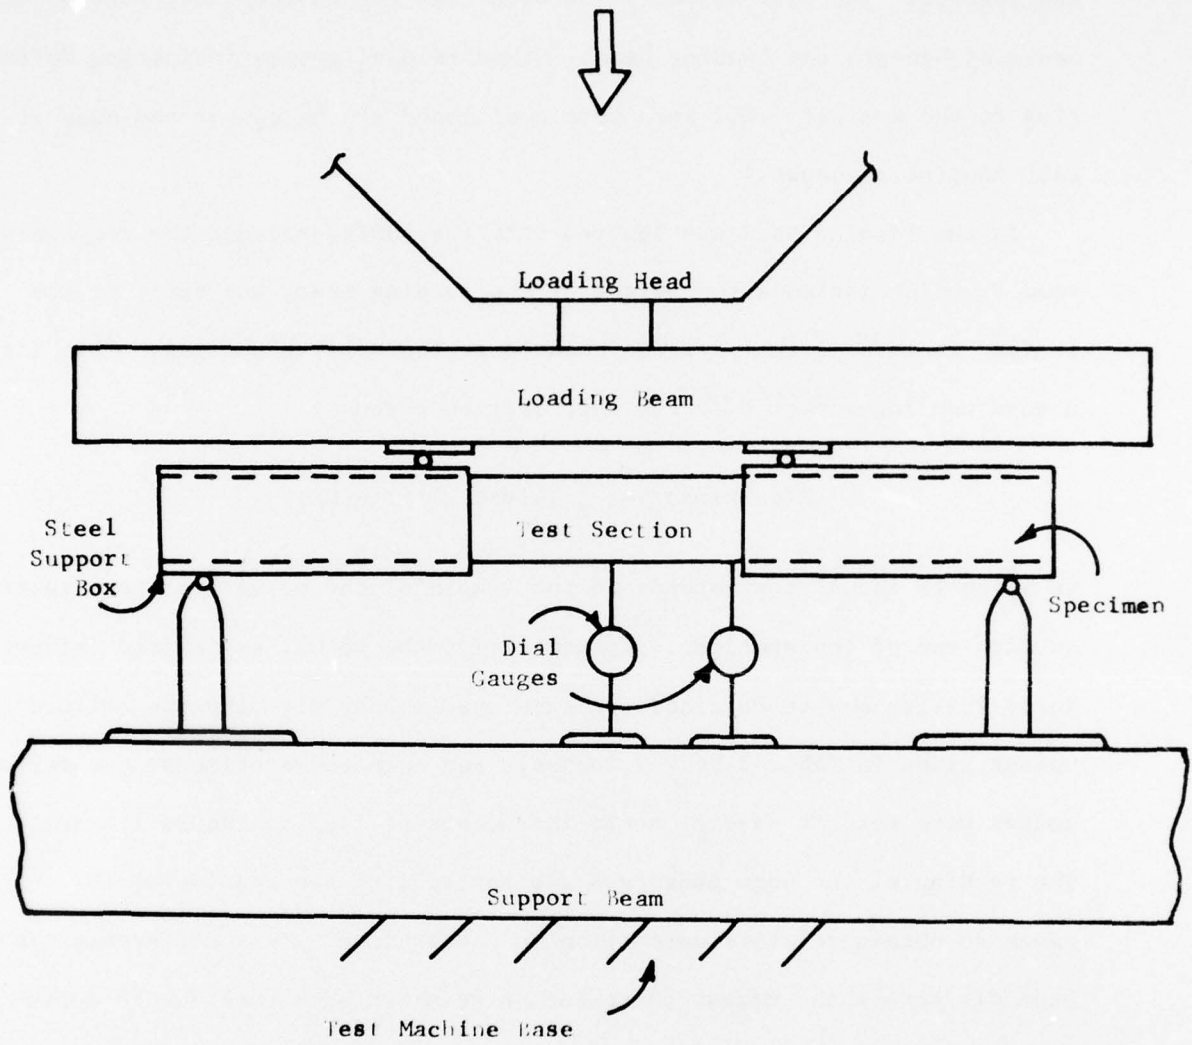
Figure 1. Test Configuration

The four-point-bending configuration is shown in Figure 1. A long steel support beam (12 WF 36) was placed on the base of the test machine. Two vertical supports approximately 12 inches high and tapering to 1-3/8-inch diameter steel roller supports were positioned on the support beam 3 inches inside each end of the 5-foot specimen. A 21-inch section on each end of the specimen was enclosed in a steel support box to prevent rotation of the specimen's unsymmetrical cross-section about a longitudinal axis. Steel loading rollers (1-3/8-inch diameter) were placed 3 inches from the inner end of each steel support box giving an effective 15-inch shear section on each end of the specimen. The loading rollers were held in place by a 6-foot

steel loading beam (6 WF 25) onto which the loading head of the test machine was lowered. The test assembly was such that the 18-inch test section was centered beneath the loading head. Standard dial gauges indicating deflection to the nearest 0.001 inch were positioned at the center and edge of the test section as shown.

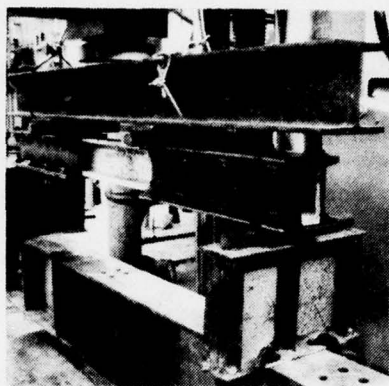
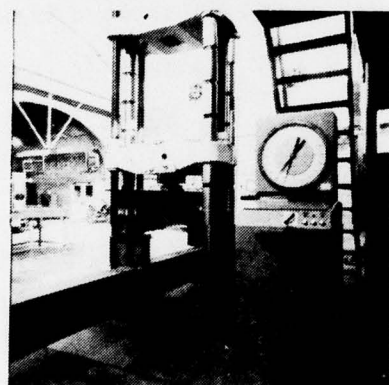
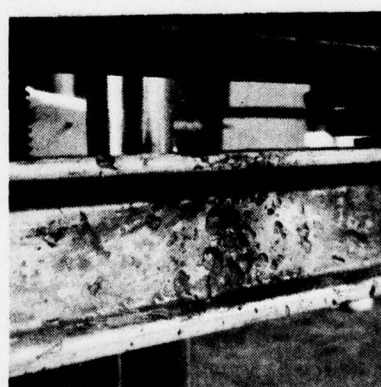
Figure 2. Photographs of Test Configuration

Six photographs are included in this paragraph to aid in describing the test configuration. Figure 2(a) shows a view taken from the front and to the right of the test assembly. The specimen shown in this and subsequent

photographs is number 118; the deflection gauges are not shown because compliance measurements were not taken for this specimen. The cable looped around the loading beam was used to prevent it from falling when the specimen failed. The support boxes are shown most clearly in Figure 2(a).

Basically they were each made of two 21-inch sections of 5 x 9 steel channel with 5/16-inch-thick steel cover plates fastened by sixteen 1/2-inch-diameter by 2-inch-long A325 heavy hex bolts and nuts. Figure 2(b) shows a closer view taken at the same angle and begins to reveal a heavily scarred web in the test section of specimen 118. Figure 2(c) shows a view of the test machine and console taken from behind and to the left of the test assembly. A closer view taken at the same angles is shown in Figure 2(d) where some spalling at the outer web surface is evident. Figures 2(e) and 2(f) show two views taken from the front and to the left of the test assembly. Details of the damage inflicted on the inner web surface of the test section are most evident in Figure 2(f).

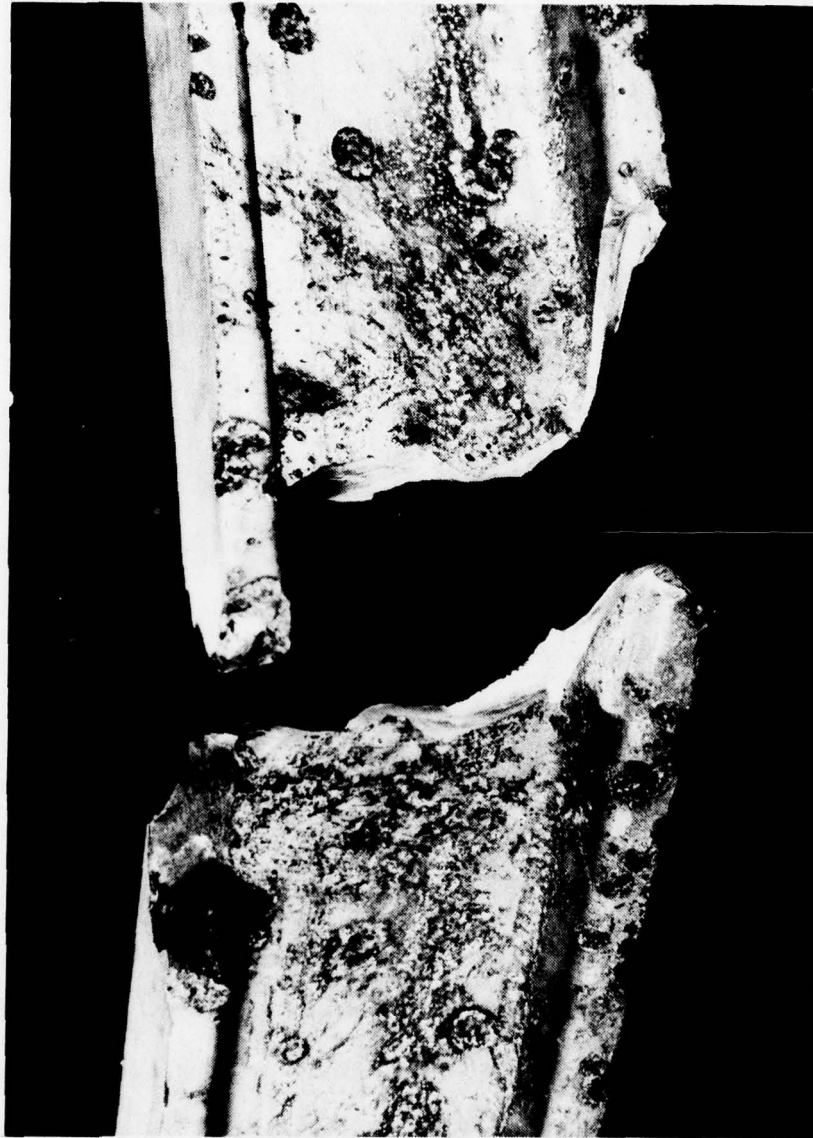
Figure 3. Failed Test Section of Specimen 20

Specimen 20 had the same type initial crack as specimen 19 except that it was only 7/8-inch long, i.e., just through the lower flange and 1/4-inch into the web. Figure 3 shows the failed test section of this specimen. The lower flange is shown on top to more clearly reveal the initial fracture surface which appears very dark in the photograph. The web was only moderately scarred, and the crack did not seem to select a path of greatest damage as it propagated through the section, exiting at one of the smaller gouges in the upper flange.

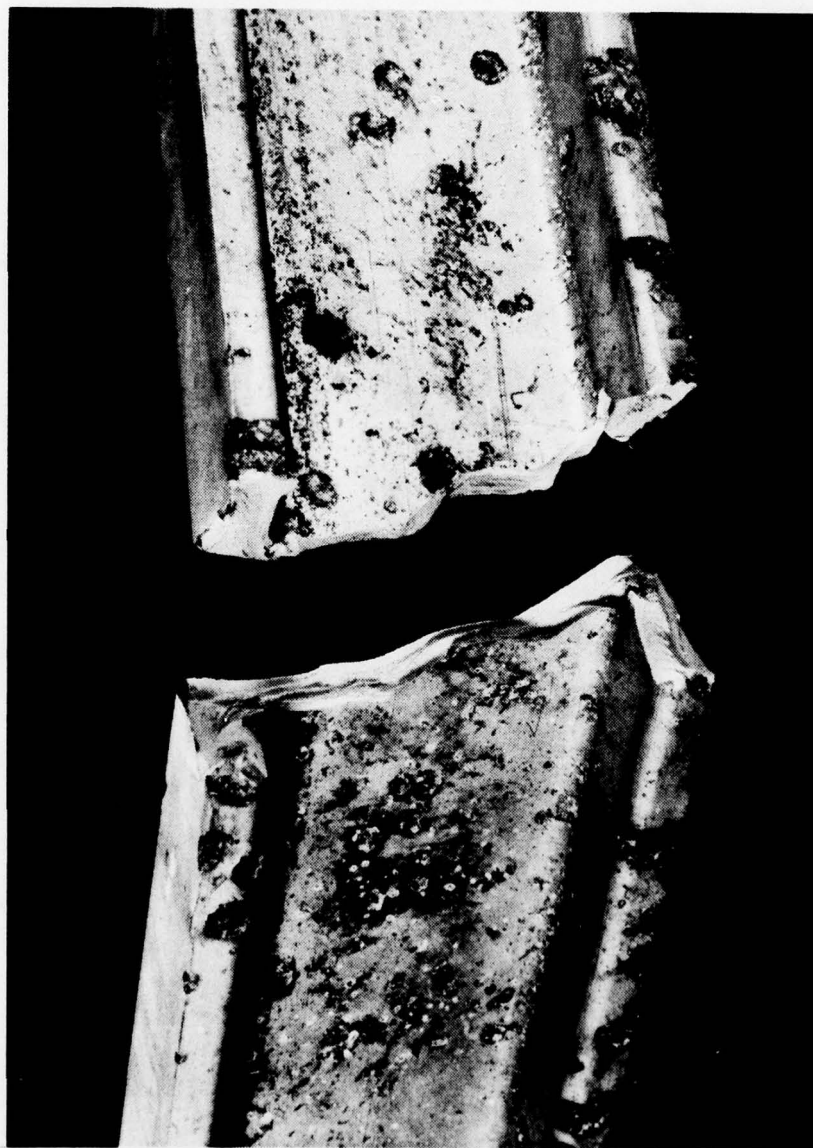
Figure 4. Failed Test Section of Specimen 22

Specimen 22 had no visible initial crack, but the lower flange (shown on top in Figure 4) had a 45/64-inch-long by 21/64-inch-deep gouge at its tip. The failure initiated at this gouge and resulted in sudden fracture of the entire section.

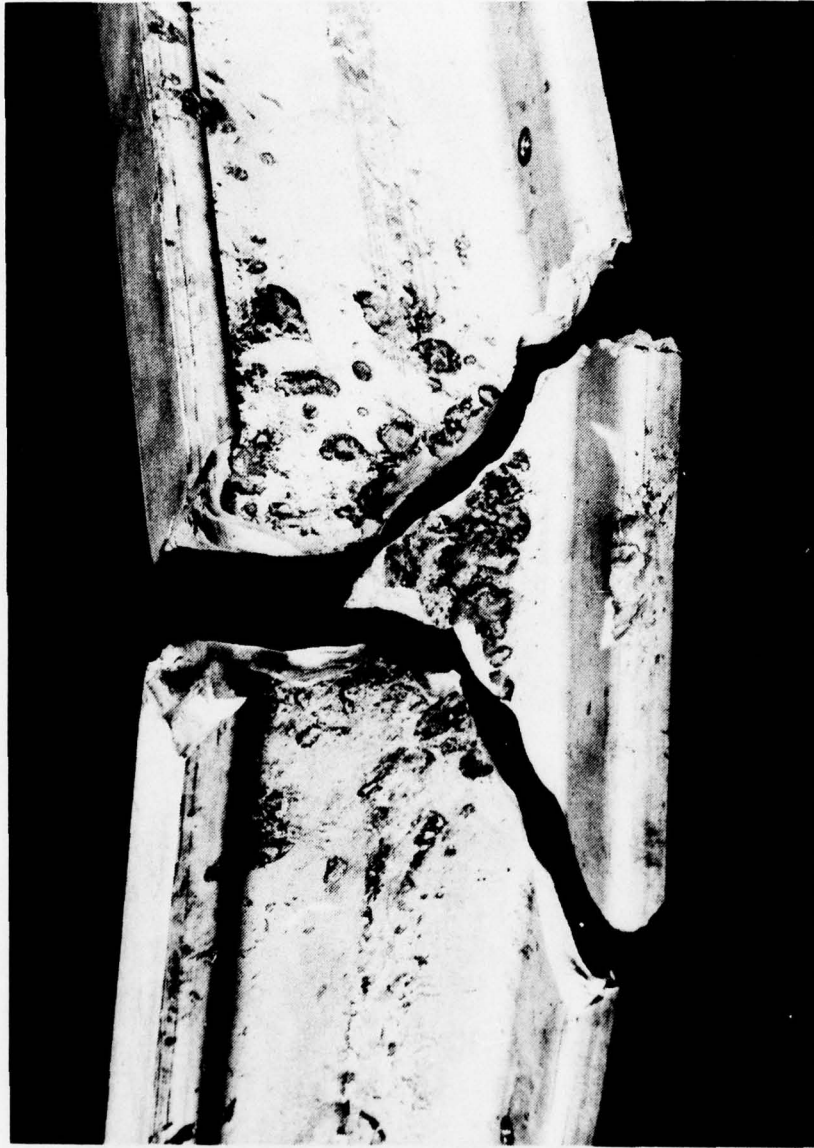
Figure 5. Failed Test Section of Specimen 26

Specimen 26 had a clean lower-flange outer surface as shown on top in Figure 5. The inner surface of the lower flange and web were moderately

scarred. The section failed suddenly with the fracture branching about halfway through the web.

that the propagating crack branched again in this specimen nearly resulting in a three-piece fracture with the smallest piece almost exactly the same shape as the one shown in Figure 5.

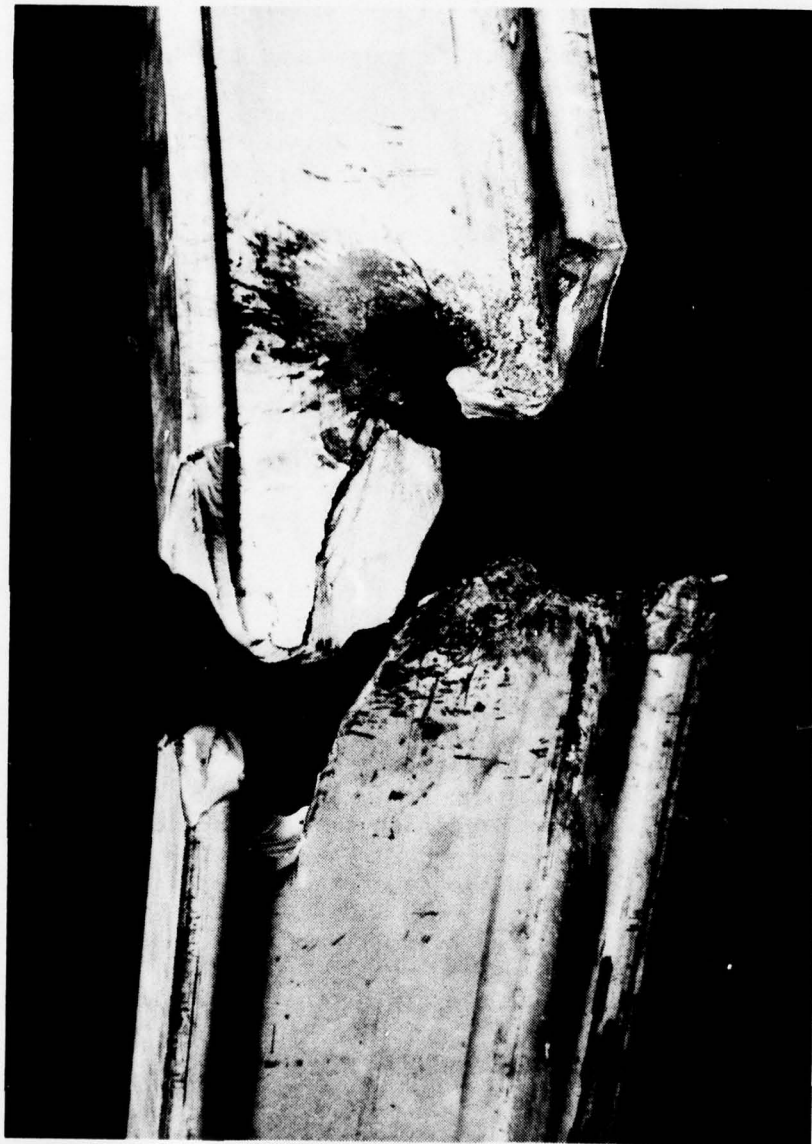
Figure 6. Failed Test Section of Specimen 30

Specimen 30 is shown in Figure 6. It had an irregularly shaped hole in the web with some peripheral fracture surface parallel to the plane of the web. The upper flange was through cracked with the crack extending into the hole. Unfortunately this beam was tested upside down and consequently showed practically no residual strength.

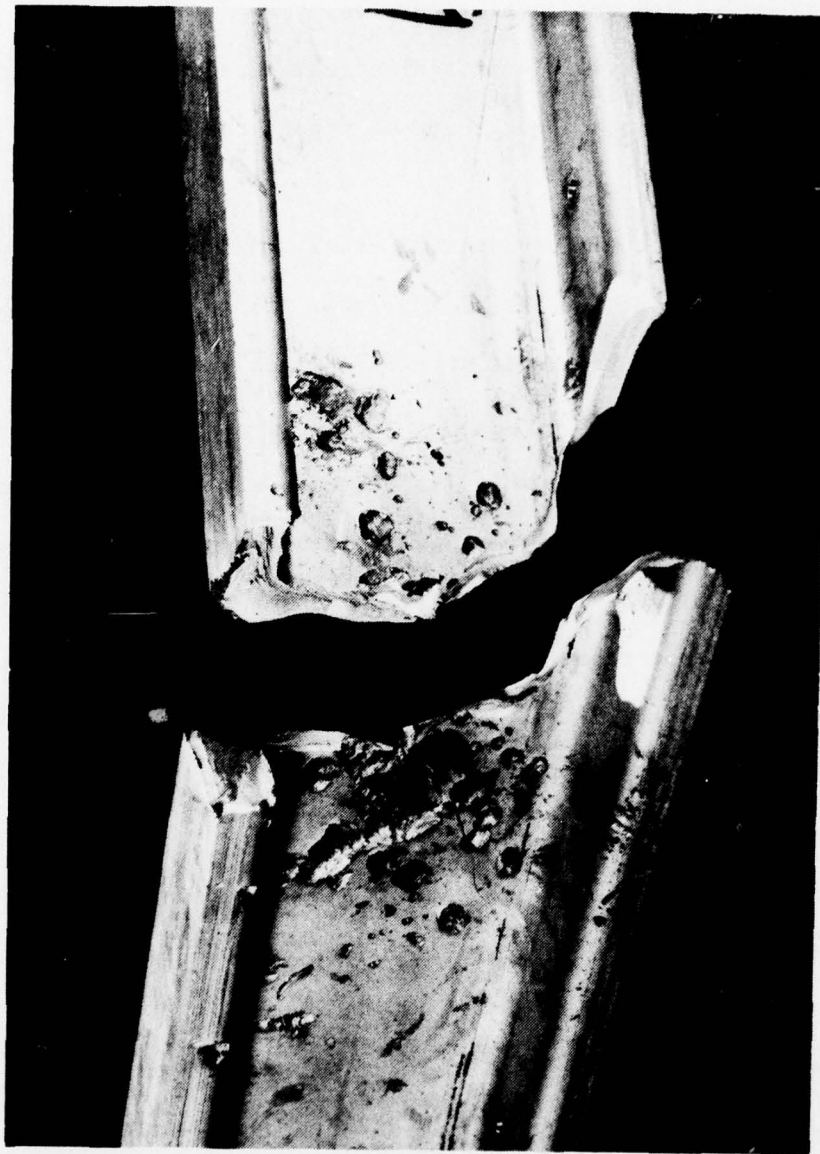
Figure 7. Failed Test Section of Specimen 109

Specimen 109 is typical of most of the specimens with no initial crack. It is shown in Figure 7 with the lower flange on top. Fracture originated at a $15/64 \times 9/64 \times 15/64$ -inch gouge at the inner corner of the tip of the lower flange. The dark part of the lower flange fracture surface in Figure 7 is grease that got on the specimen as it fell onto the support beam. Notice

Specimen 120 had a small gouge at the inner corner of the lower surface. The fracture bifurcated and almost resulted in a three-piece failure (see Figure 7).

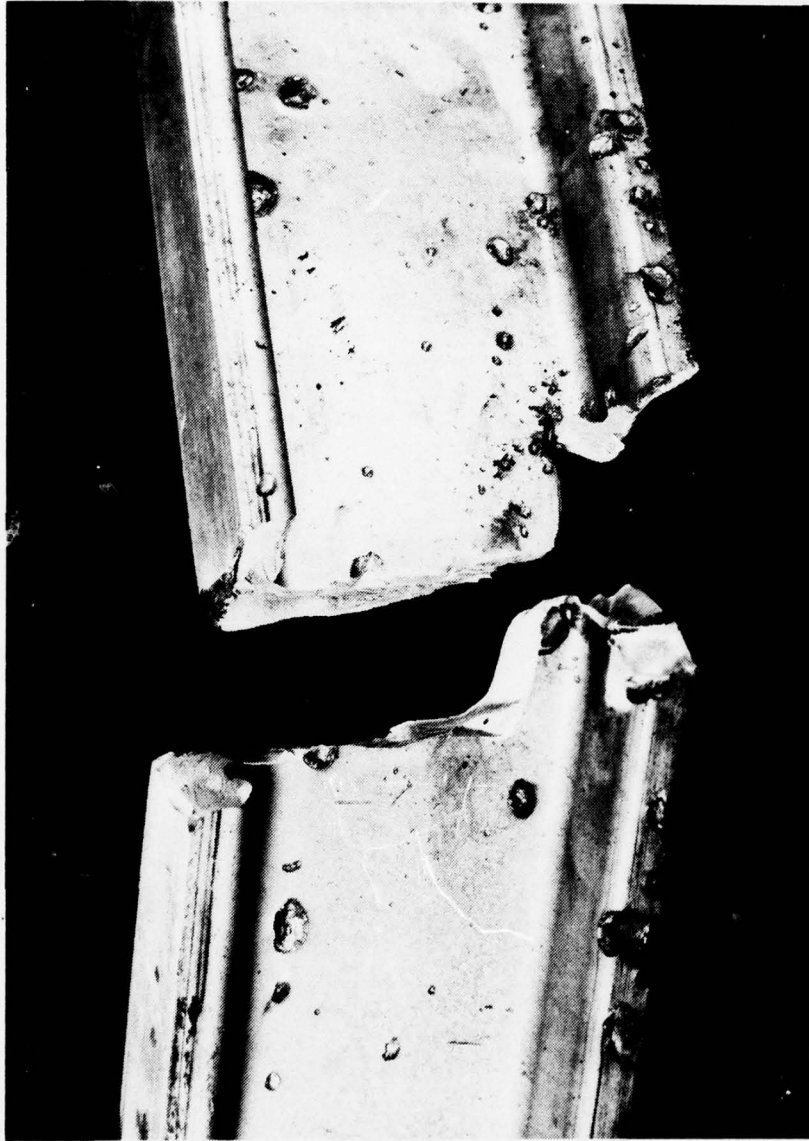
Figure 8. Failed Test Section of Specimen 124

Specimen 124 is shown in Figure 8 with the lower flange up to show more clearly the nick at the outside corner that promoted fracture. The dark grease spot on the lower flange should again be ignored as it was picked up as the broken beam impacted the support beam.

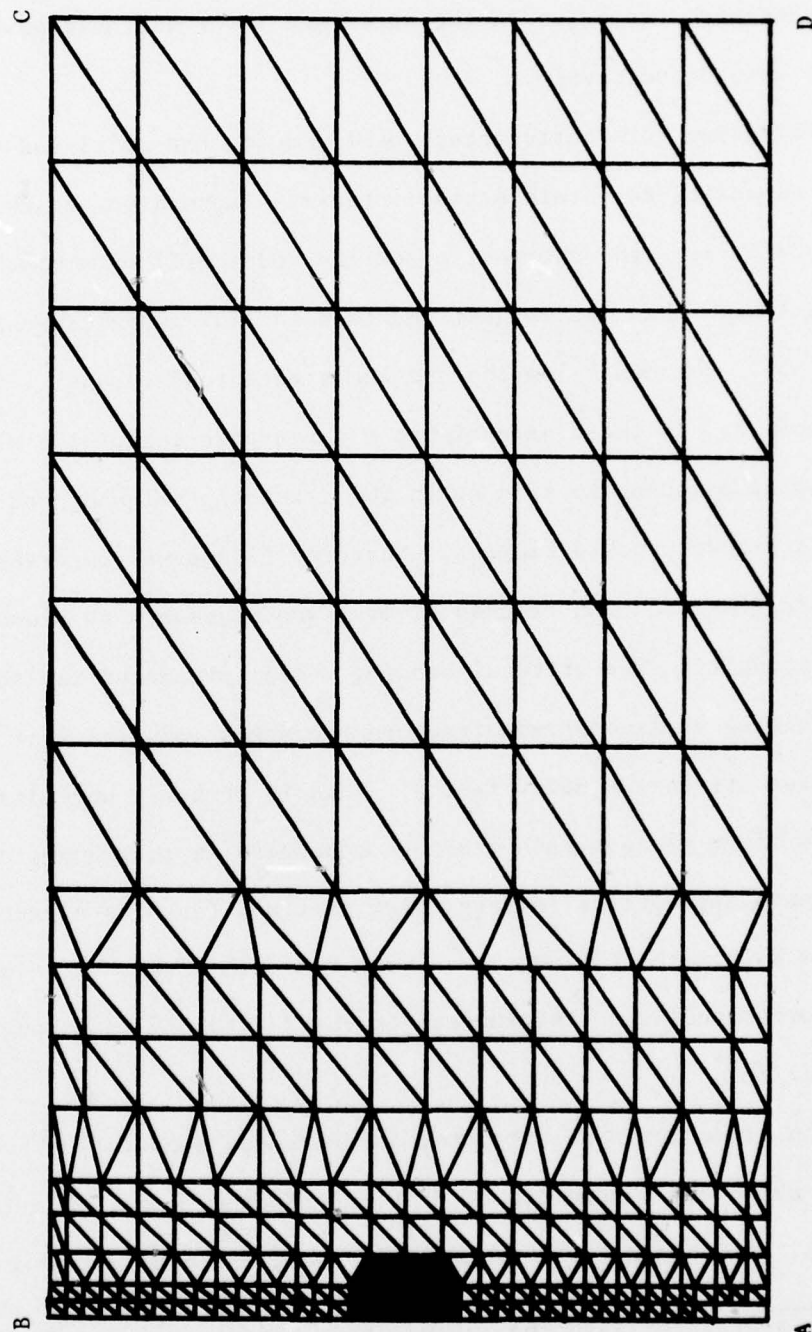
Figure 9. Finite-Element Representation of One-Half the Test Section

advantage of longitudinal symmetry about a hypothetical, centrally located, plane fracture surface) was appropriate. Figure 9 shows such a finite-element representation.

The finite-element model shown consists of 297 nodes and 514 constant-strain triangles. Nodes along left edge AB correspond to points lying on the crack face and along the prospective fracture surface. Nodes on the crack face are unrestrained; nodes on AB ahead of the crack tip are constrained to move vertically by horizontal forces. All nodes on AB are free of vertical forces, a condition consistent with AB being a line of symmetry. Free edges BC and AD correspond to the outer surfaces of the upper and lower flanges, respectively. Edge CD corresponds to the right-hand end of the test section. Nodes on this edge were subjected to horizontal forces whose distribution vertically is statically equivalent to the classical continuous stress distribution resulting from a unit in-kip applied bending moment.

The thickness of the flanges (represented by the upper and lower horizontal bay of triangles in the coarser part of the model) was taken to be uniformly equal to 2 inches. The thickness of the web was taken to be uniformly equal to 1/2 inch. Material parameters input were: Young's modulus (E) = 10.3×10^3 ksi; Poisson's ratio (ν) = 0.30. The model shows the 8-node cracked element at A corresponding to the shortest crack length ($a = 3/16$ inch) considered.

The computer program CRAKD was executed for this model first with no initial crack to verify that stresses due to the pure bending moment were being adequately computed in the refined section. Theoretically, the maximum bending stresses for a unit in-kip moment and a section modulus of 5.7 in.³

($14.24 \text{ in}^4 / 2.5 \text{ in.}$) should be 0.176 ksi. Averages of the two smallest and outermost triangles on the upper and lower surfaces gave -0.174 ksi and 0.175 ksi, respectively.

In order to numerically confirm that two damage sites must be almost contiguous to reinforce one another, the finite-element model shown in Figure 9 was modified slightly to produce a central web perforation that measured 1-inch long by $3/4$ -inch high. One-half the perforation is shown shaded in Figure 9. The model was then executed for four crack lengths ($3/16$, $13/16$, $1\ 7/16$, and $2\ 1/16$ inches) measured from the outer surface of the lower flange. Notice that for the longest crack length considered, the crack tip was only $3/16$ inch from the edge of the hole. The results presented as stress-intensity factors (as computed with and without the hole) as a function of crack length are shown in Figure 11. As expected from a recollection of

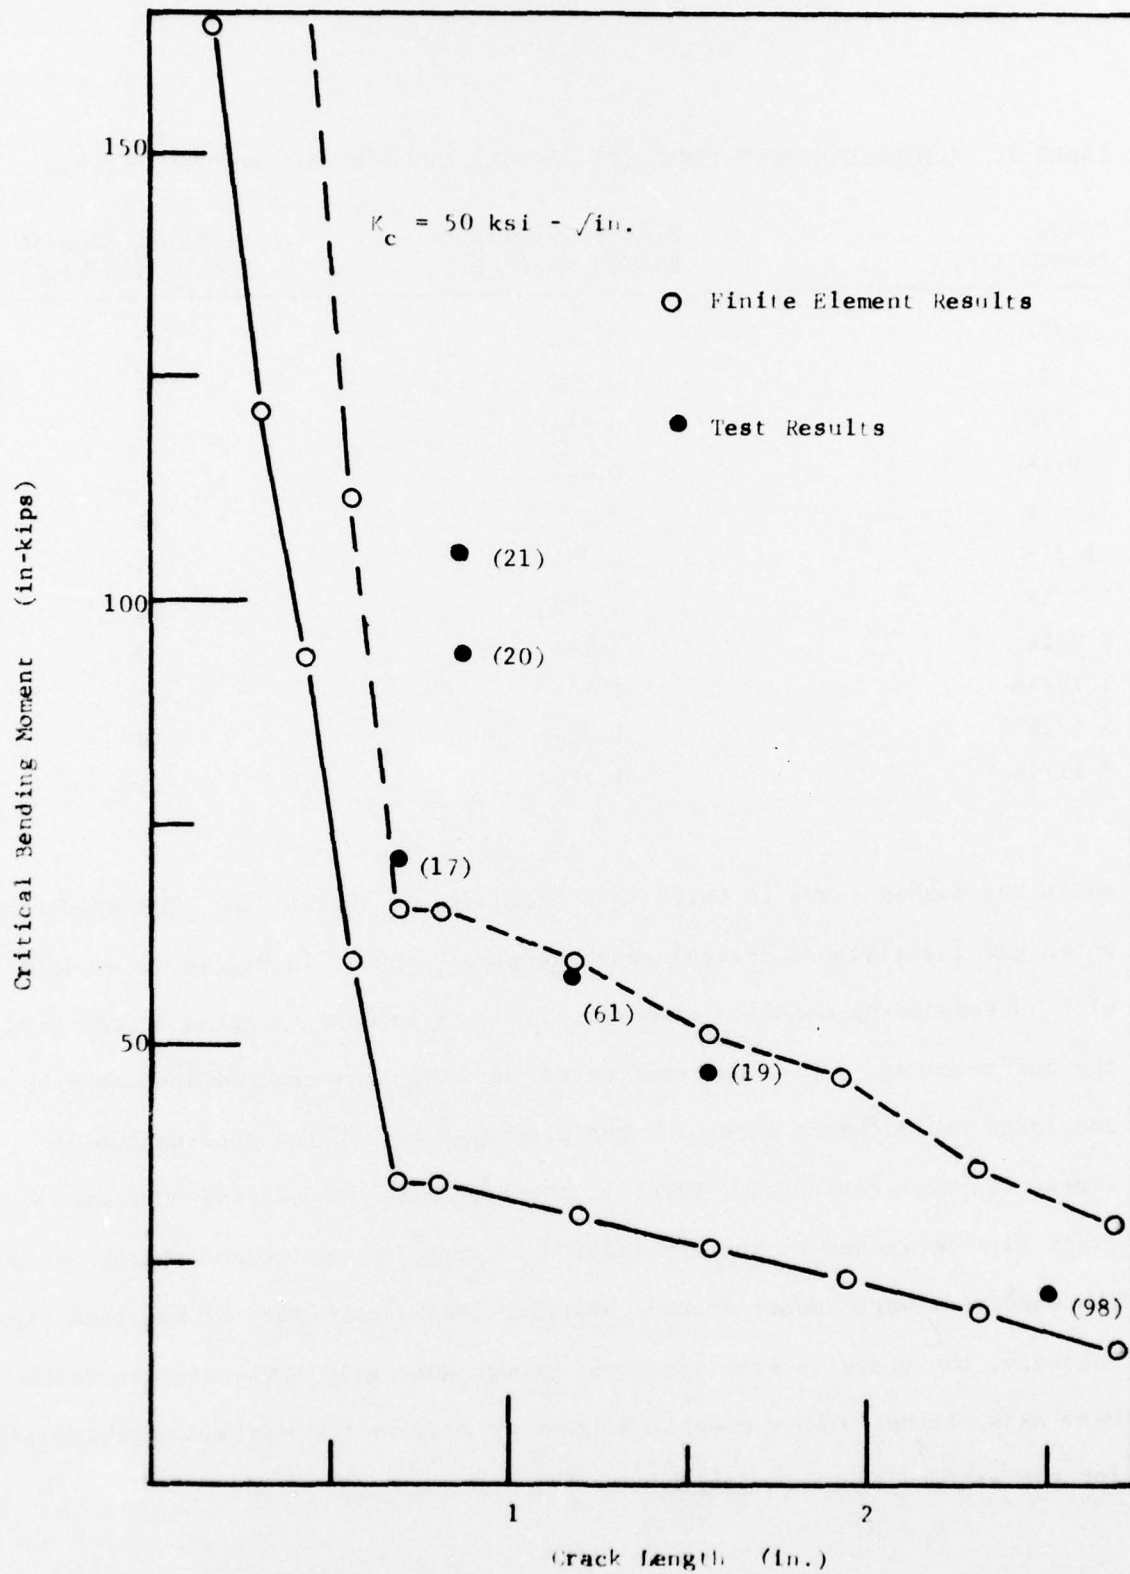
Figure 10. Residual Strength Versus Crack Length

The effect of this parameter is presented graphically in Figure 10, which shows the dependence of critical bending moment upon initial crack length. The solid curve is based on the plane-strain fracture toughness

while the dashed curve is based on a toughness of $50 \text{ ksi}\sqrt{\text{in}}$. The specimens which had identifiable initial crack lengths appear in Figure 10 as dots with corresponding specimen numbers. The data appears to agree better with the dotted curve. It is not unexpected that even the cracked specimens by and large exhibit more strength than predicted by routine application of linear fracture mechanics. Firstly, the toughness values used correspond to crack tips sharpened by the application of many low-amplitude fatigue cycles; the specimens were impact cracked and doubtlessly have more blunt crack tips. Secondly, the crack in each specimen, though generally perpendicular to the beam axis, is not always exactly aligned to produce the minimum breaking load for the particular crack length.

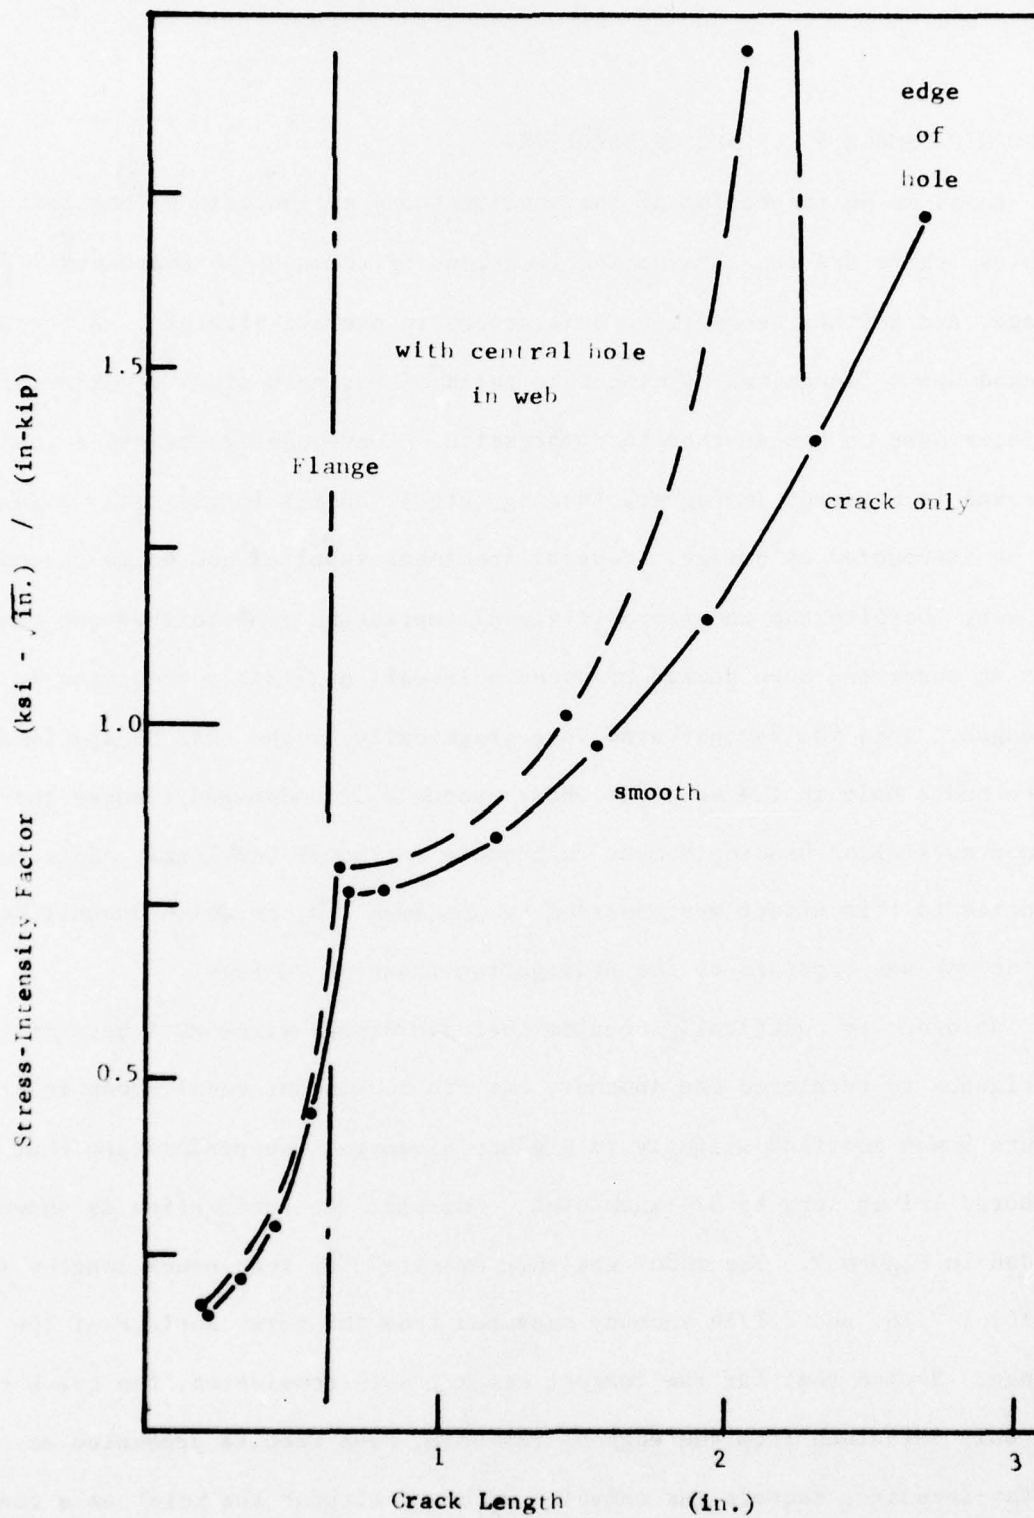
Figure 11. Interaction of Nearby Damage Sites

the test results, the stress-intensity factor is effectively insensitive to the presence of the hole until it is within 1 inch of the edge. Consequently, it is felt that damage interaction can be reasonably ignored in future analyses.

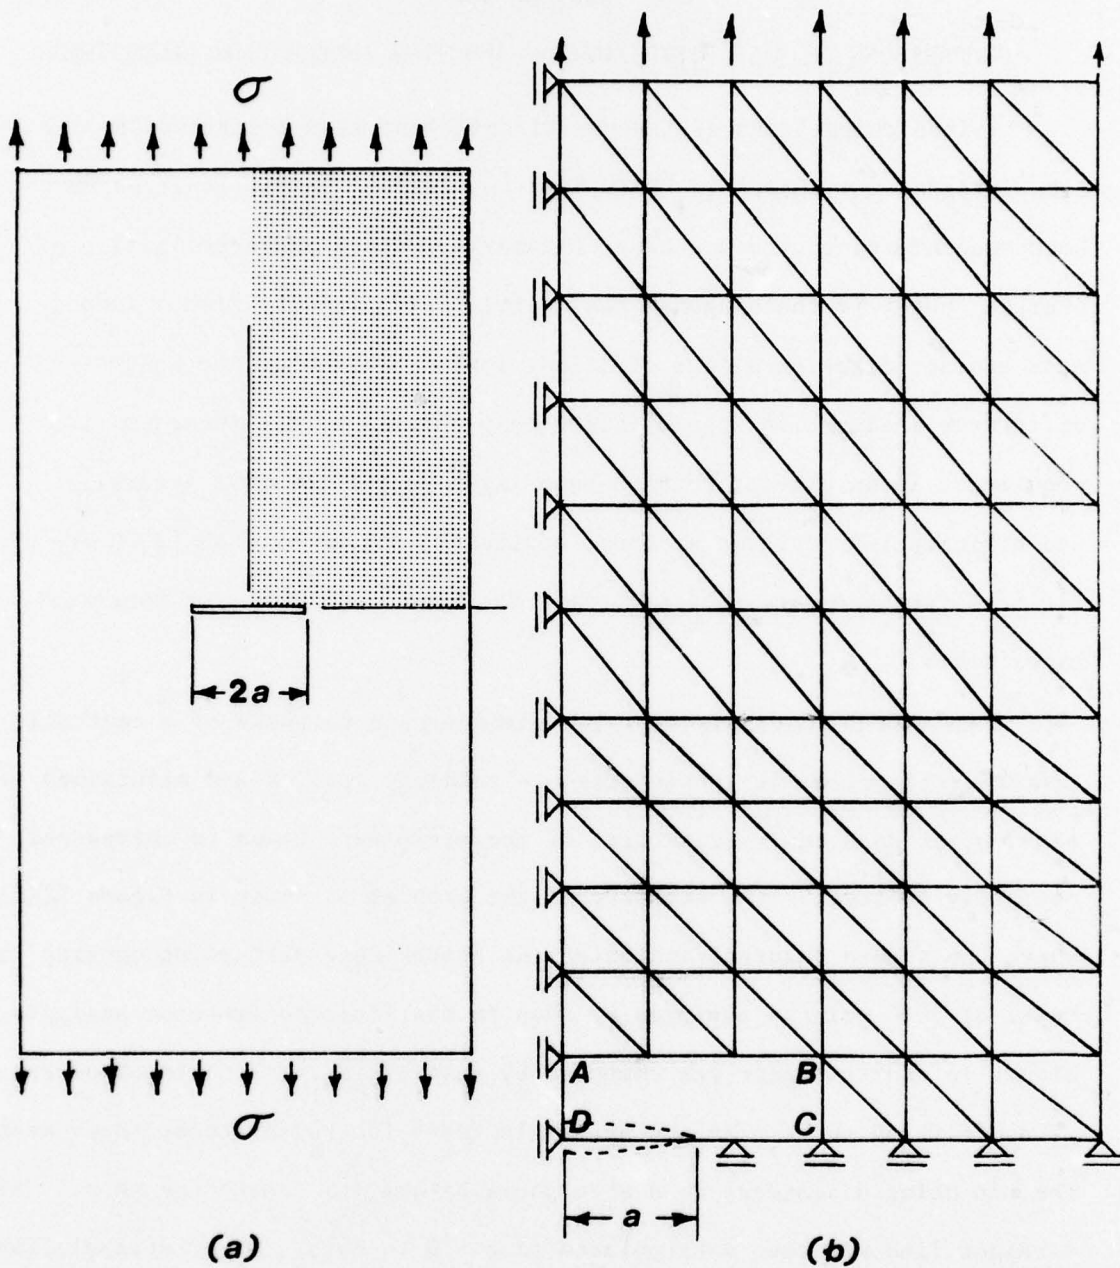
Figure 12. Chen's Problem and Its Finite-Element Representation

Chen's problem consists of the plane-strain response of a centrally-cracked rectangular strip subjected to suddenly applied and maintained tension, σ , at each end. Properties of the strip were taken to correspond nominally to steel. The geometry of the problem is shown in Figure 12(a) where the shaded quadrant indicates the approximate mesh-point density (a total of 5000 points) employed by Chen in his finite-difference analysis. The stress-intensity factor was computed by multiplying components of stress by \sqrt{r} and fitting those near the crack-tip (data for two or three zones nearest the tip being discarded) to a straight-line spatial dependence on r . This straight line was then extrapolated to $r = 0$ to obtain K_I . Extrapolations along radial lines in several different directions were reported to agree within 5 percent. Chen's time-dependent stress-intensity factor normalized

A finite-element model representing the shaded quadrant of Chen's problem is shown in Figure 12(b). It consists of 84 nodes, 126 constant-strain triangles, and one 8-node singularity element ABCD. Depicted by open circles in Figure 13 are results obtained by this finite-element model using the consistent-mass characterization of inertia and the Newmark- β integration scheme. The time integration was accomplished with 75 steps each of 0.2 microsecond; this choice of time increment was motivated by the transit time (0.22 microsecond) of a longitudinal wave across the smallest of the triangular elements. The finite-element results, which are in substantial agreement with Chen's analysis, were obtained in 26 seconds of computation time on a UNIVAC 1108 computer during a low-demand period of the Georgia Institute of Technology time-sharing system.

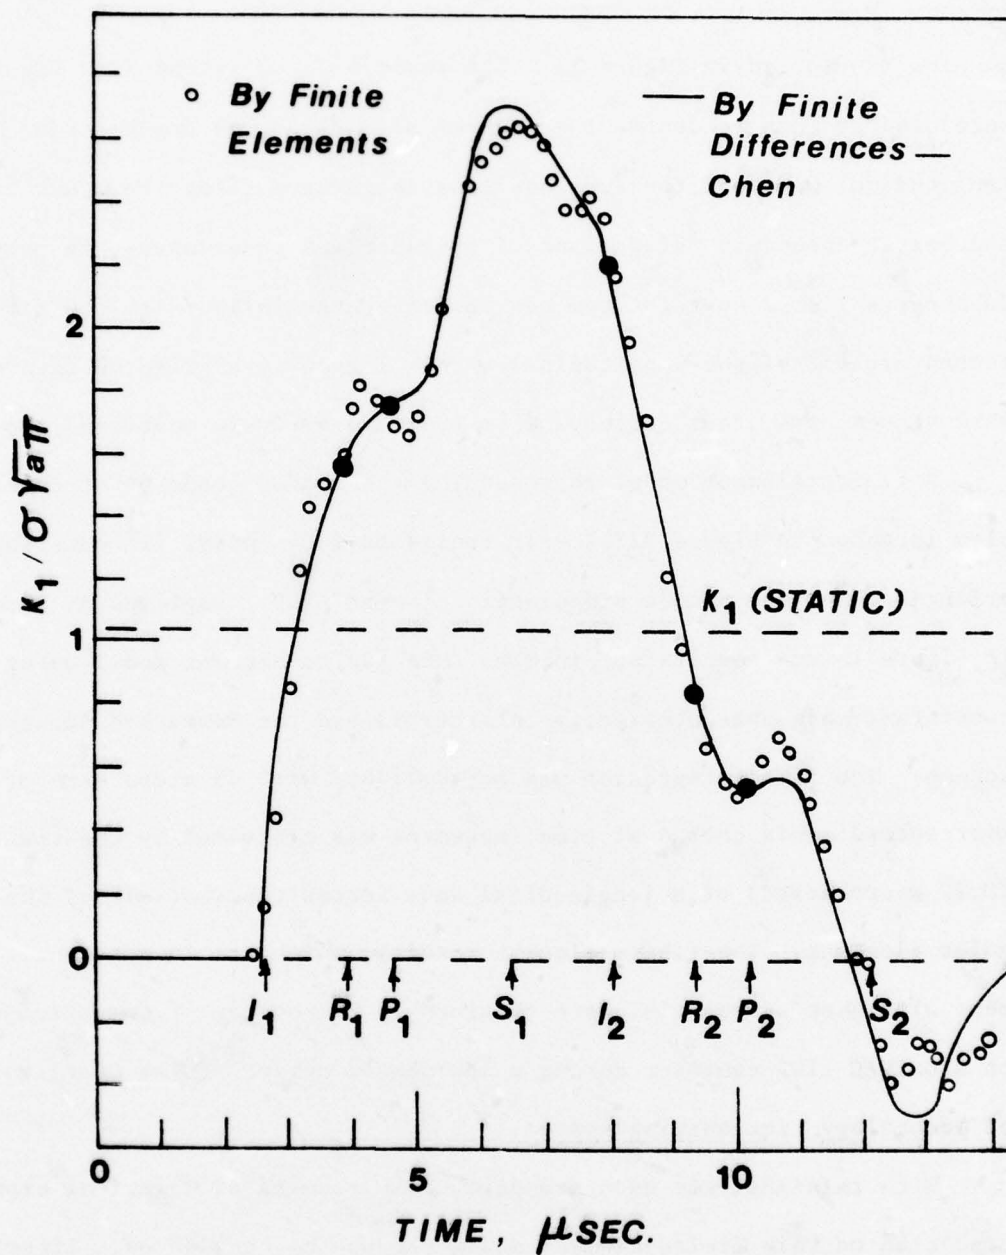
Figure 13. Comparison of Results Obtained Using Finite-Difference and Finite-Element Methods for Chen's Problem

by $\sigma/\pi a$ is plotted in Figure 13. The symbols I, R, P, and S in Figure 13 were used by Chen to denote the time of arrival at the crack-tip of the longitudinal wave and the subsequent Rayleigh wave (from the other tip) and nearest-boundary reflections of pressure and shear waves, respectively. Subscripts 1 or 2 on these symbols indicate association with the first or second arrival of the longitudinal wave. The solid circles on Chen's curve mark values of K_I that correspond to the wave arrivals mentioned above.

With this analysis as a standard, some results of numerical experiments conducted on this finite-element model can now be considered. Firstly, time dependence of the stress-intensity factor predicted by a lumped-mass version of this model can be compared with that obtained from the consistent-mass version. This comparison is shown in Figure 14. In each case the Newmark- β method with a time step of 0.2 microsecond was employed. These results are

in substantial agreement, with the most striking differences occurring around sharp local maxima and minima of the stress-intensity factor. At such times the contributions of high-frequency modes of vibration are most evident, and these modes are not likely to be accurately represented by the relatively coarse finite-element model regardless of the method of allocation of inertia. The lumped-mass model predicts a peak stress-intensity factor 5 percent higher than that reported by Chen while the consistent-mass model predicts a value 2 percent lower than that of Chen.

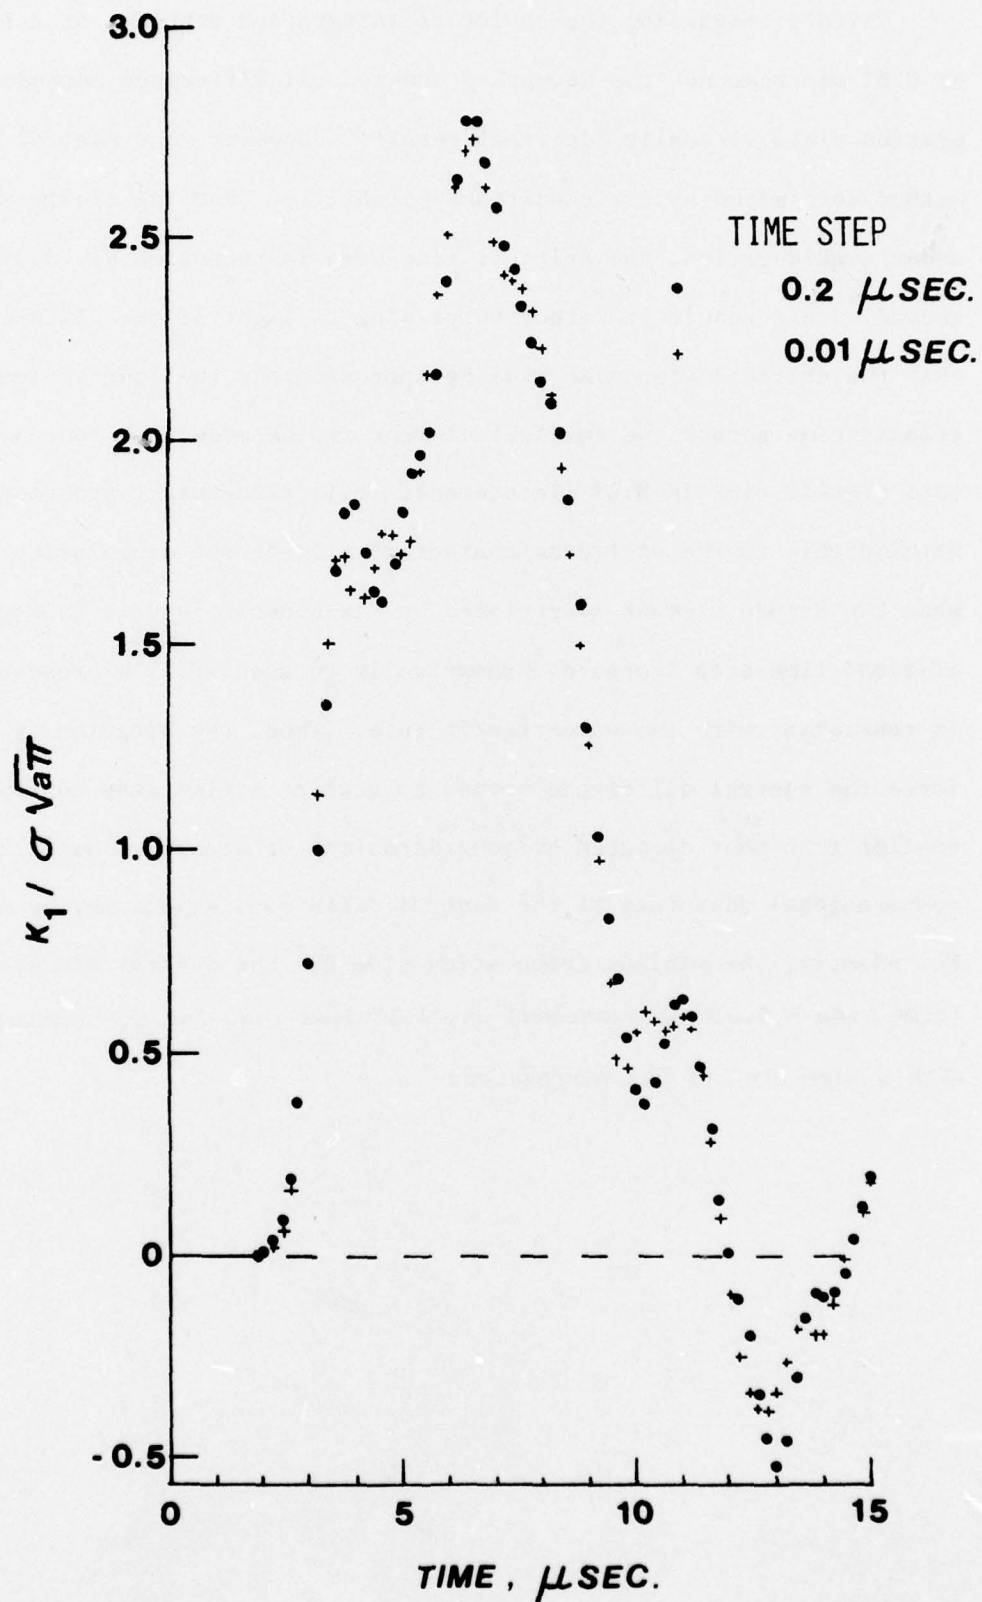
Figure 15. Effect of Time-Step Size for Chen's Problem

Secondly, the effect of a substantial reduction of the time step utilized in the numerical integration can be seen in Figure 15 where results obtained from the lumped-mass model, utilizing the Newmark- β algorithm with time steps of 0.2 microsecond and 0.01 microsecond, are presented. It can be remarked here for later consideration that, at the smaller time-step, the central difference method produces results indistinguishable from those of the Newmark- β method when plotted to the scale of Figure 15. Furthermore, no differences were detectable when the time step was reduced to 0.0027 microsecond, indicating that, for practical purposes, convergence has been achieved with the 0.01 microsecond step size. Clearly, the 0.2-microsecond time step is too large for accurate representation of contributions of the high-frequency modes of the finite-element model in this problem. However, it is apparent that this time step is adequate for characterizing the more significant features of the dynamic response and the use of a much smaller increment is hardly justified without a simultaneous refinement of the finite-element grid.

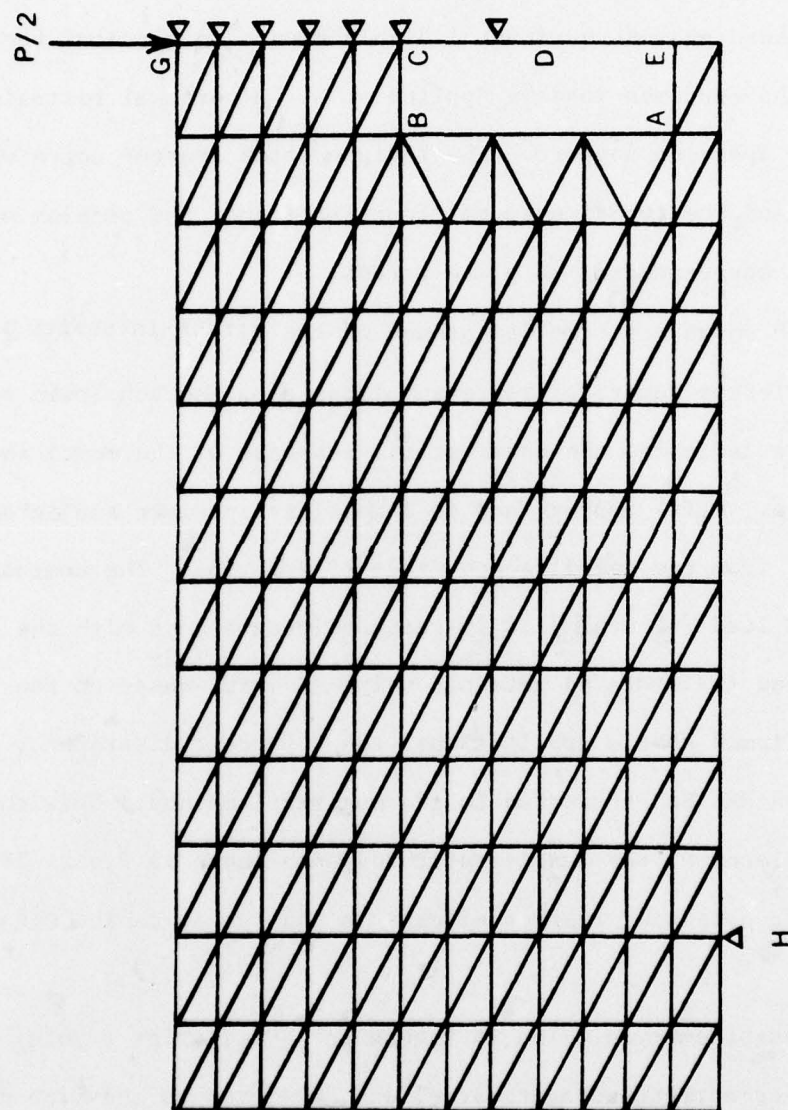
Figure 17. Finite-Element Model of the Madison-Irwin Specimen

Figure 17 shows a finite-element representation of a Madison-Irwin test specimen. Due to symmetry about the plane of the crack, only the left half of the specimen is modelled. The model consists of 163 nodes, 273 constant-

strain triangles, and 1 eight-node crack-tip singularity element. The singularity element ABCDE is required to accurately represent the locally severe stress gradients in the neighborhood of the fatigue crack tip at D. Consistent with symmetry requirements, nodes along the crack's prolongation DG are restrained against horizontal displacement. A vertical force equal to one-half the specimen load is applied at G. A vertical restraint at H simulates the specimen support. The fatigue-crack starter notch was not represented, and the two-dimensional idealization of the problem was taken to be the one corresponding to plane stress.

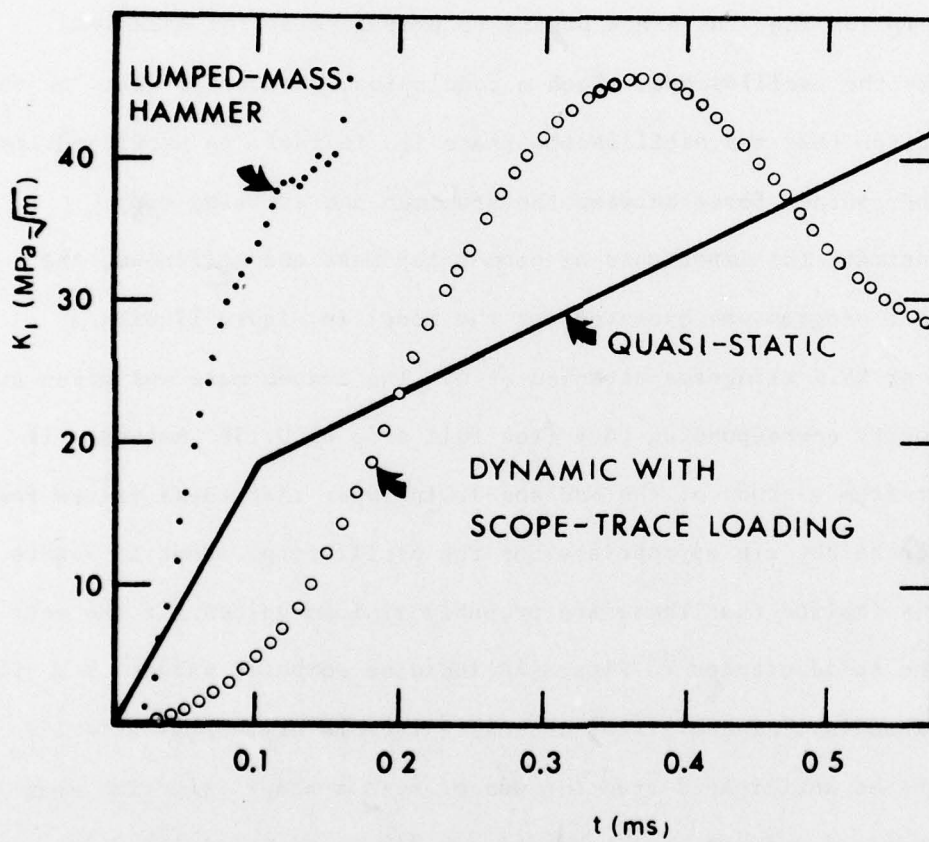
Figure 18. Results of Finite-Element Analyses of the Madison-Irwin Impact Test

Figure 18 shows the time dependence of the stress-intensity factor K_I for three different numerical representations of a Madison-Irwin experiment. The solid line indicates the quasi-static response of the model shown in Figure 18, i.e., $K_I(t)$ appropriate to a massless specimen subjected to the load as taken from the oscilloscope trace (Figure 16). The computed value of K_I at peak load ($42 \text{ MPa}\sqrt{\text{m}}$) is in reasonable agreement with the Madison-Irwin estimates ($43.7 \text{ MPa}\sqrt{\text{m}}$) obtained using (3), but based on the results of previous confirmed static applications, the 4 percent discrepancy is somewhat more than can be attributed to the numerical method. Notwithstanding the small difference, the quasi-static response shown in Figure 18 is used as a basis for assessing inertia effects in the two companion dynamic executions.

The locus of empty circles in Figure 18 is $K_I(t)$ for a model with inertia characteristics corresponding to steel and subjected to the time-dependent load of Figure 16. The integration time step was 10^{-2} ms , and K_I was computed at each time step. The smoothness and shape of the response indicates the

adequacy of this time step and confirms the earlier estimate of the period. The considerable difference between the dynamic and quasi-static responses is exclusively the result of specimen inertia. When specimen inertia is included, the peak stress-intensity factor is elevated by more than 8 percent above the maximum quasi-static value. More importantly, the peaks occur at significantly different times. So for the particular geometry and loading rate under consideration, the dynamic result is in clear conflict with an assumption that the crack begins to propagate at the peak load registered by the oscilloscope. Such a conclusion, of course, rests on the tacit assumption that the oscilloscope trace is, in fact, an accurate time record of the contact force between the specimen and striking tup.
